WATERSTOP FAILURE IN TUNNEL AT
COMPLEX I-C, LARSON AIR FORCE
BASE, TITAN I FACILITY

WWW.CHROMEHOOVES.NET MISCELLANEOUS PAPER NO. 3-534

September 1962

SUBJECT: Water Stop Failure in Tunnel at Complex 1-C, Larson Air Force Base,
Titan I Facility

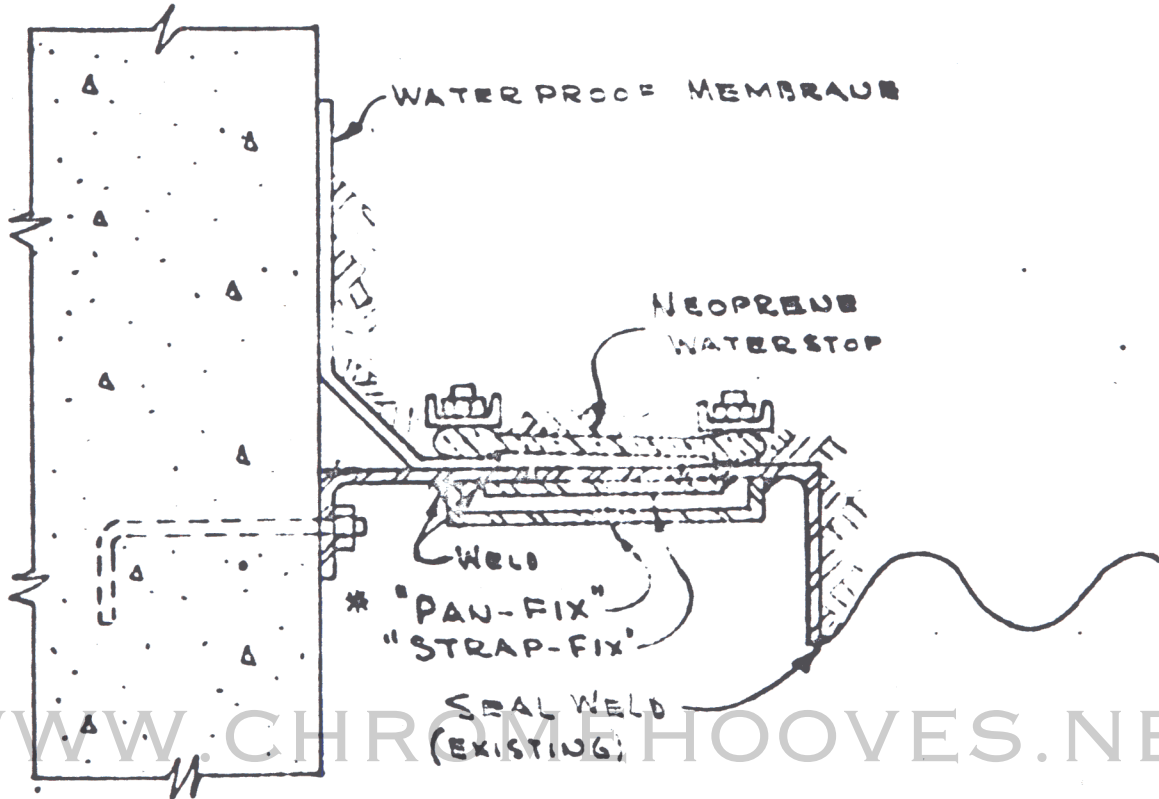
TYPICAL CONNECTION BETWEEN TUNNEL LINERS AND CONCRETE STRUCTURES

5. The design of the complex required that a 4-in. open space be left between the metal tunnel liners and the metal rings on adjacent concrete structures. This space was sealed by placing a neoprene water stop around the outside circumferences of the tunnel liners and metal rings on the concrete structures, as shown in inclosure 1; this would afford flexibility at the joints in the event of large ground movements; the flexibility of the joints is referred to as the hardness factor. A typical connection between the tunnel liners and concrete structures is shown in inclosure 1.

6. After the ground water started rising around the tunnels, it was observed that some of the water stops were bulging inward as a result of hydrostatic pressure and it was felt that they should be strengthened. As a result, some of the water stops were reinforced by so-called strap fixes placed on the inside of the tunnel around the upper 300-degree area of the circumference of the tunnel. The water stop in the bottom 60-degree area of the circumference of the tunnel was reinforced by covering it with novaculite. The strap fixes consisted of a steel strap, approximately the width of the gap between the tunnel liner and the metal ring attached to the concrete structures, placed against the water stop with narrow metal straps welded at 1-ft intervals to hold it in place. A typical strap fix is shown in inclosure 1.

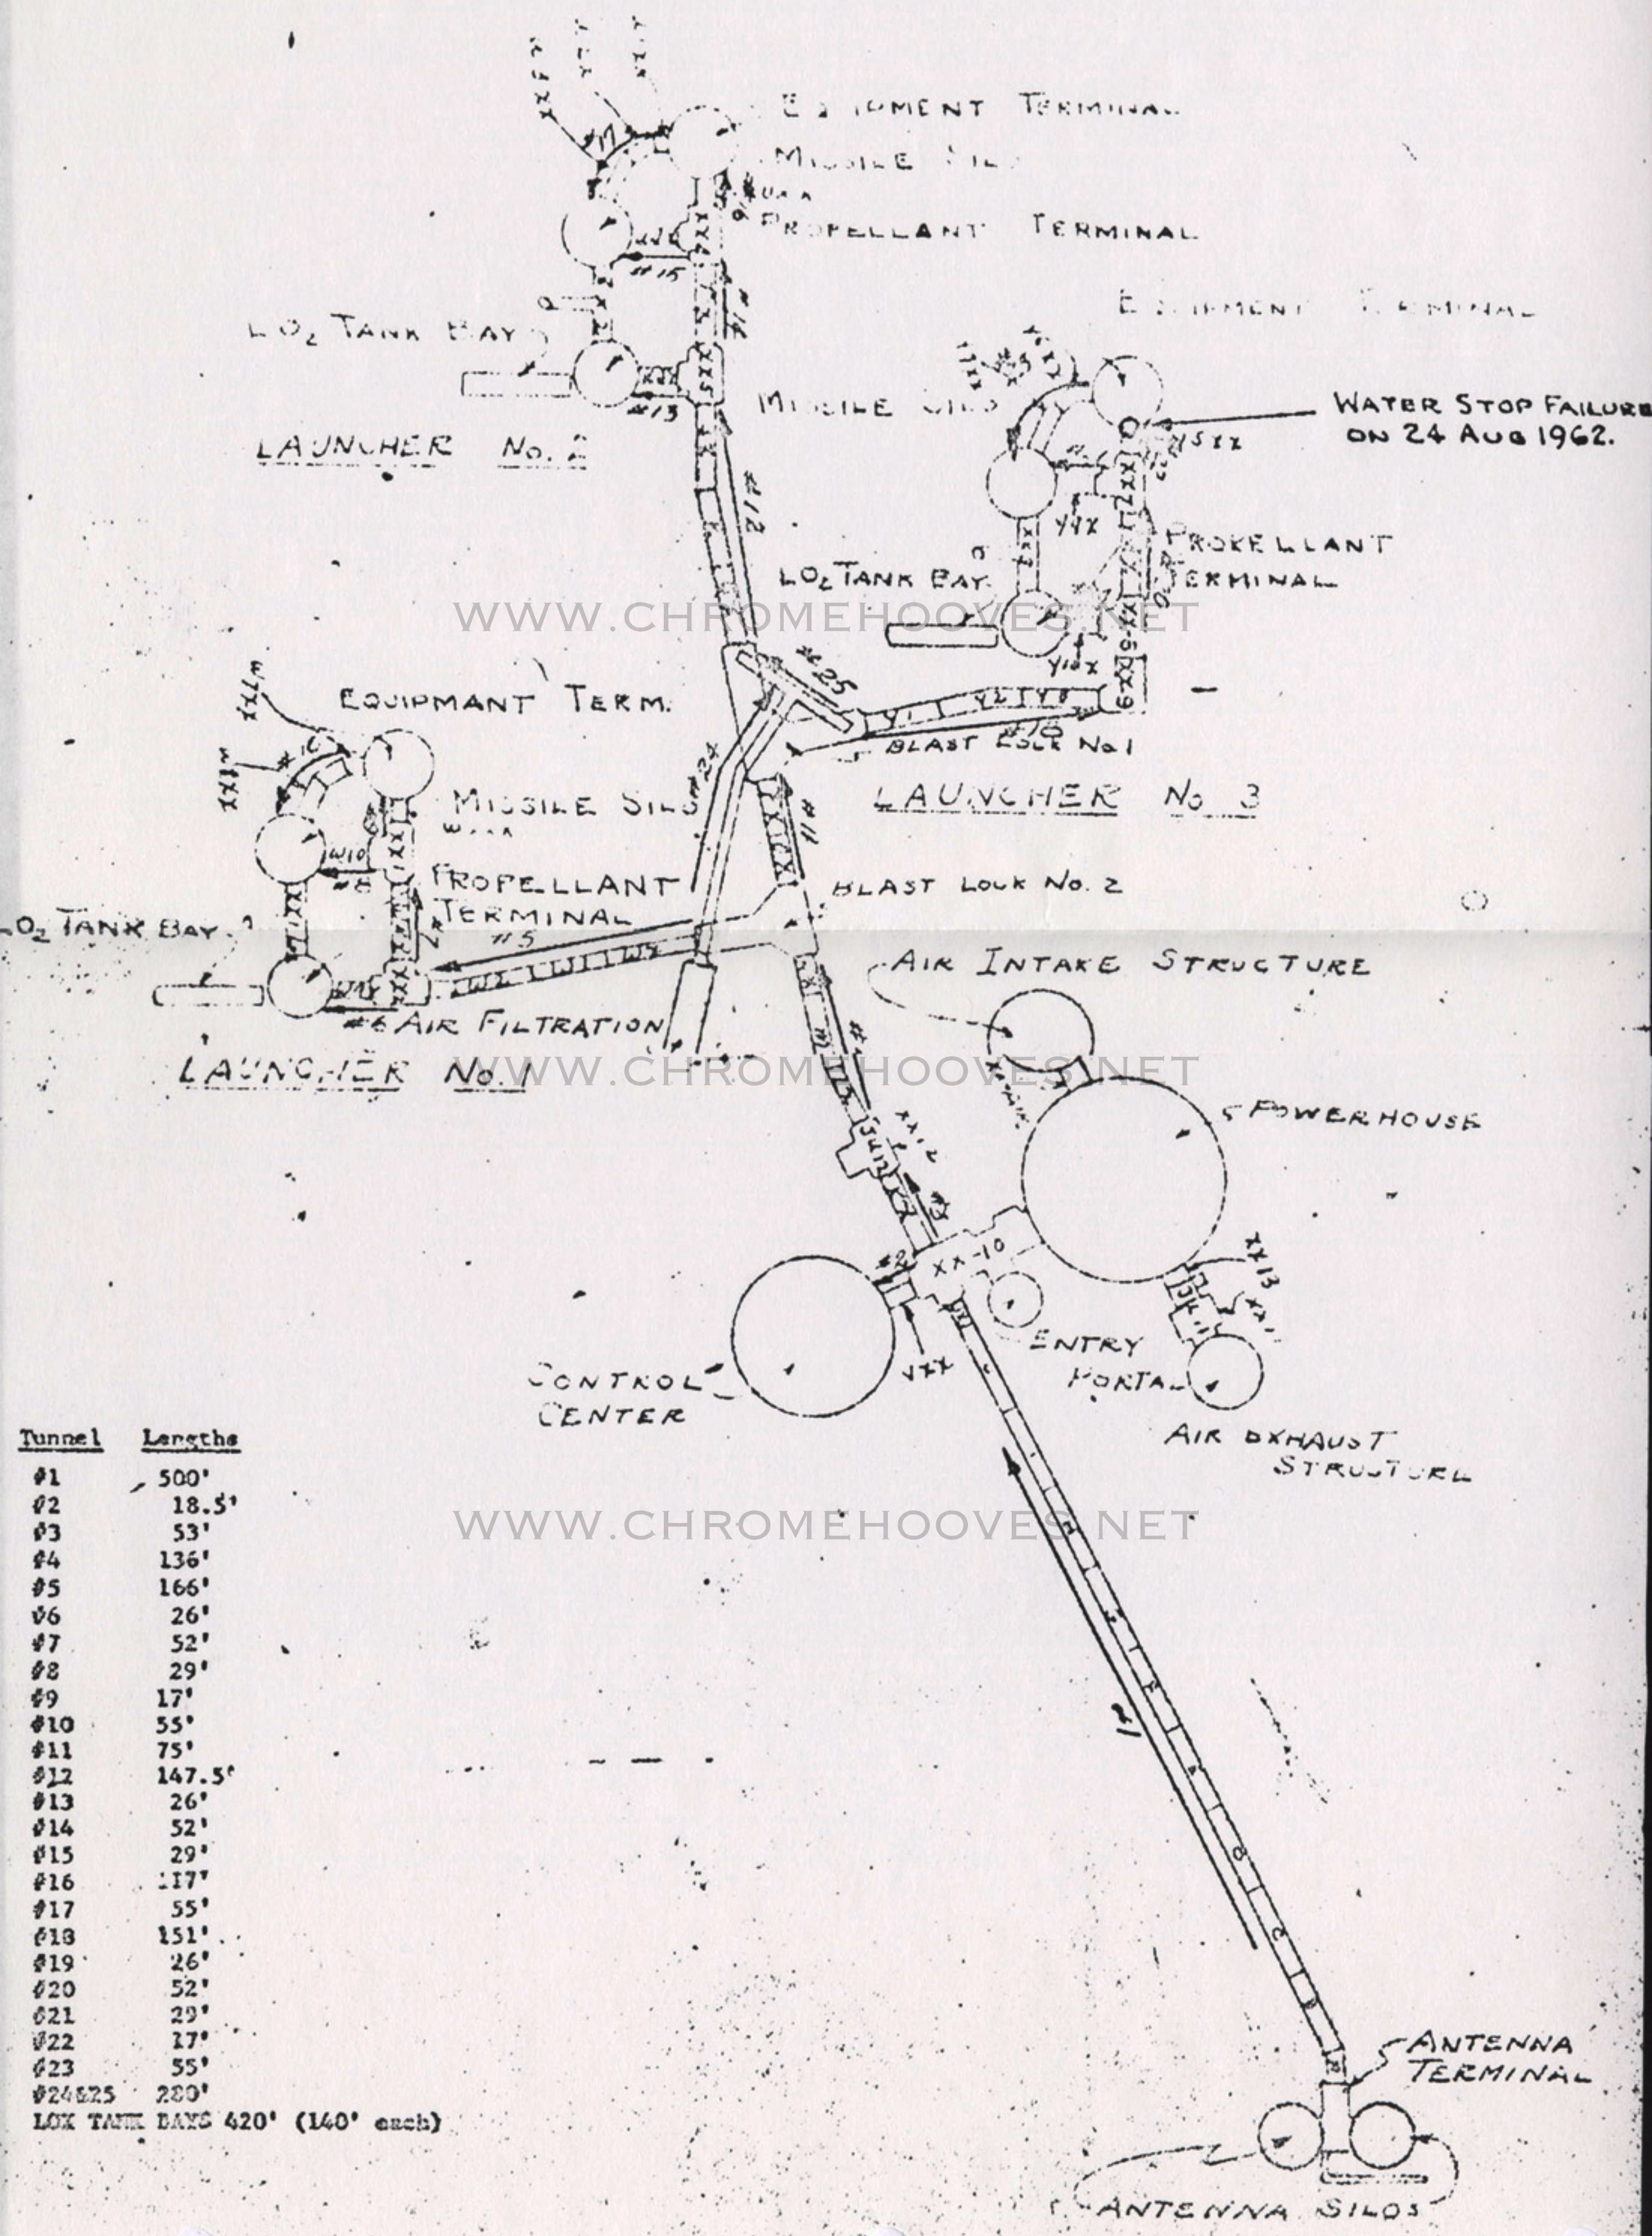
7. At 4:30 p.m. on Friday, 24 August, a 14-in.-long, 4-in.-wide piece of the water stop in the bottom of the tunnel between the tunnel liner and equipment terminal at Launcher No. 3 was forced inward into the tunnel and torn loose by hydrostatic pressure, permitting inflow of ground water into the tunnel at an estimated rate of 20,000 gallons per hour. When the failure occurred, AM-9 grout was being injected through the tunnel liners to stop leaks around bolt heads inside the tunnel at a point several hundred feet distant from the failure area; it was not felt that these grouting operations had anything to do with the failure. The location of the failure is shown in inclosure 2.
