SECTION 5

RESULTS AND CONCLUSIONS

5.3 ANALYSIS OF DEM PA01039 ELECTRICAL FAILURE

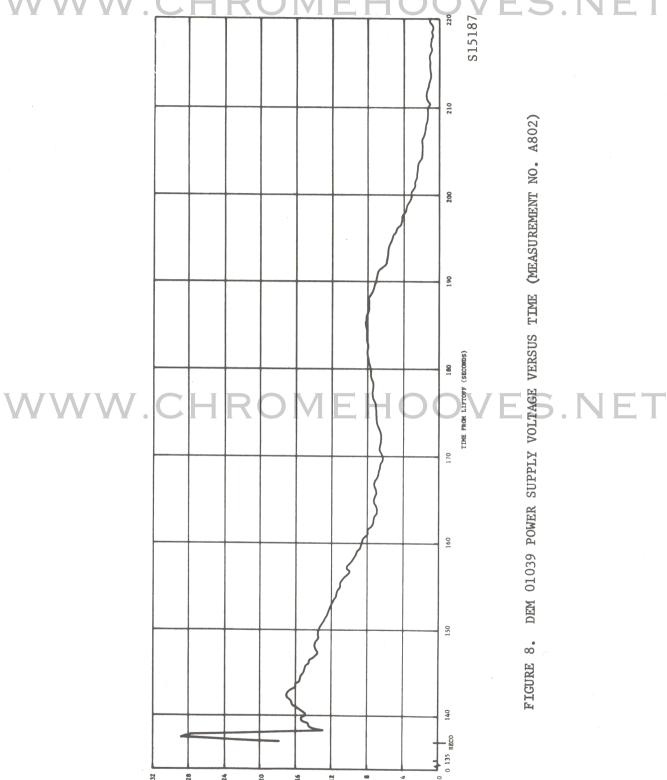
DEM PA01039 failed to operate because of a failure in the electrical system. This section presents an analysis of the possible causes of this failure, as follows:

- Partial activation of the battery because of faulty cell construction or insufficient electrolyte added to cells at time of activation.
- (2) Short circuits located:
 - (a) within the power supply,
 - (b) in the squib circuitry (beyond the current-limiting resistors R31 and R32), or,
 - (c) in the sequence distribution box (ahead of the current-limiting resistors).

Figure 7 shows the complete electrical system schematic.

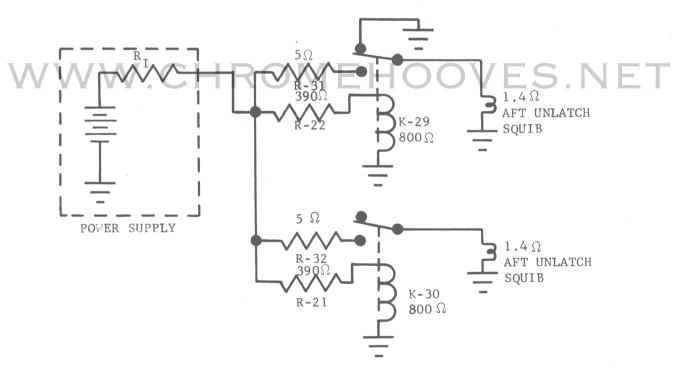
FIGURE 9. ELECTRICAL SCHEMATIC

To explain the above statement, a brief description of the circuits involved at the time of activation (see Figure 9) is given, with some information on the characteristics of the power supply.

The circuit shown in Figure 9 works as follows. As the power supply is activated and the voltage starts to rise (0.2 second nominal to reach 30 volts), the aft attach squib relays close between 13.4 and 20.8 volts. The current required prior to pull-in of relays, K-29 and K-30 is

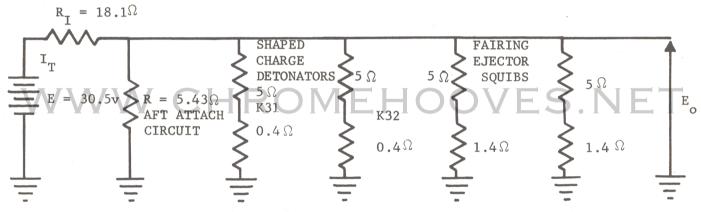
FIGURE 11. ELECTRICAL SCHEMATIC

Now assume that the R_L remains constant and R_I increases, causing a proportional decrease in E_O. The situation at BECO + 30 can then be evaluated. At this time, E_O = 7 volts. Then R_I = $\frac{(23.5)(5.4)}{7}$ = 18.1 ohms and the circuit is as shown in Figure 11.

As in the earlier case, a momentary drop in voltage during squib firing might not be detected on the commutated measurement, but here the voltage would remain at a partially-reduced level because the ejector squibs did not fire and would continue to draw current.

which is less than the no-fire current for the detonators (Reference No. 7). Therefore, it can be concluded that the shaped charge could not have fired if partial activation of the battery had been the cause of failure. The other possible mode of failure, a short circuit, is examined in paragraph 5.3.2.

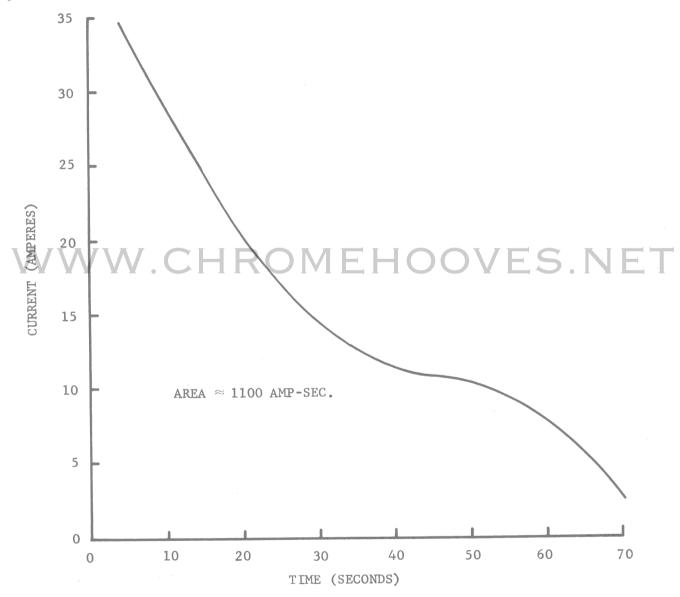
FIGURE 13. CALCULATED POWER SUPPLY OUTPUT

Plotting the current calculated for these points yields a curve as shown in Figure 13, the integration of which yields a discharge capacity of 1100 ampere-seconds. The value obtained for the lot sample battery was 928 ampere-seconds, which was measured to the point where the supply voltage dropped to 25.2 volts. The 1100 ampere-second figure then compares closely with previous results, lending support to the assumption that the power supply produced its full output and must have been fully activated.

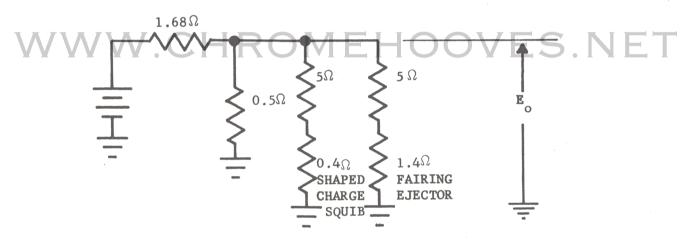
FIGURE 14. ELECTRICAL SCHEMATIC

The situation at BECO + 30 seconds is now examined, based on the above argument. The circuit (simplified) can be represented as shown in Figure 14 and the following values can be calculated:

These values indicate that, under the assumed short-circuit condition, the fairing probably could not eject but the forward attach strap could be cut by the shaped charge, since the shaped charge detonators have been fired at as

little as 0.7 amperes in ground tests. This analysis, then, reconstructs the operation of the DEM, as it actually occurred, as shown by telemetry measurements.

Therefore, on the basis of this analysis, it is reasonable to conclude that the failure was caused by a short circuit. It should be mentioned that this type of failure can occur only between the power supply and the current-limiting resistors in series with each squib. Any shorting of the squibs will not affect the power supply because of the limiting action of the resistors and their fuse characteristics. The resistors always burn open with the application of full power supply load through them. Any current less than 3 amps will not burn open the resistor but, at the same time, the power supply output voltage will not drop lower than 28 volts.

The only malfunction encountered on this flight was the electrical system power failure in DEM 01039. As noted in the analysis of that failure (Section 5.3), it is considered a random, in-flight failure, and therefore no corrective action is planned other than a continuing effort to identify specific hardware features or conditions which might cause such a short-circuit.
