9.2 PROPELLANT LOADING AND PRESSURIZATION SYSTEM

The flight test of Missile VS-1 was performed on 3 May 1961. Fuel loading was initiated at R-12 hours after successfully completing the PLPS automatic checkout per Procedure 644F-2. Fuel loading was completed without incident with a maximum flow rate of 285 GPM being obtained. Lox loading was initiated at R-115 minutes. Flow rates were approximately 235 GPM from Truck No. 1 (1627), 200 GPM from Truck No. 2 (1035), and 182 GPM from Truck No. 3 (185). The flow rate from Truck No. 4 (182) was not calculated due to insufficient information. Truck Nos. 1 and 2 operated at a nominal pressure of 45 PSIG. Truck Nos. 3 and 4 were equipped with an automatic pressurization system set up for 25 PSIG. Lox loading was complete at R-22 minutes. This was 13 minutes ahead of allotted countdown time. Review of the PLPS film coverage indicates that the 100.5% point sensor was extinguished at 13:08:01 or R-42.7 seconds although it did illuminate several times after the lox tank was pressurized. T-120 seconds occurred at 13:08:43.7 and T-0 seconds at 13:10:43.7. The PLPS systems appeared to function normally throughout the count. No adverse effects were

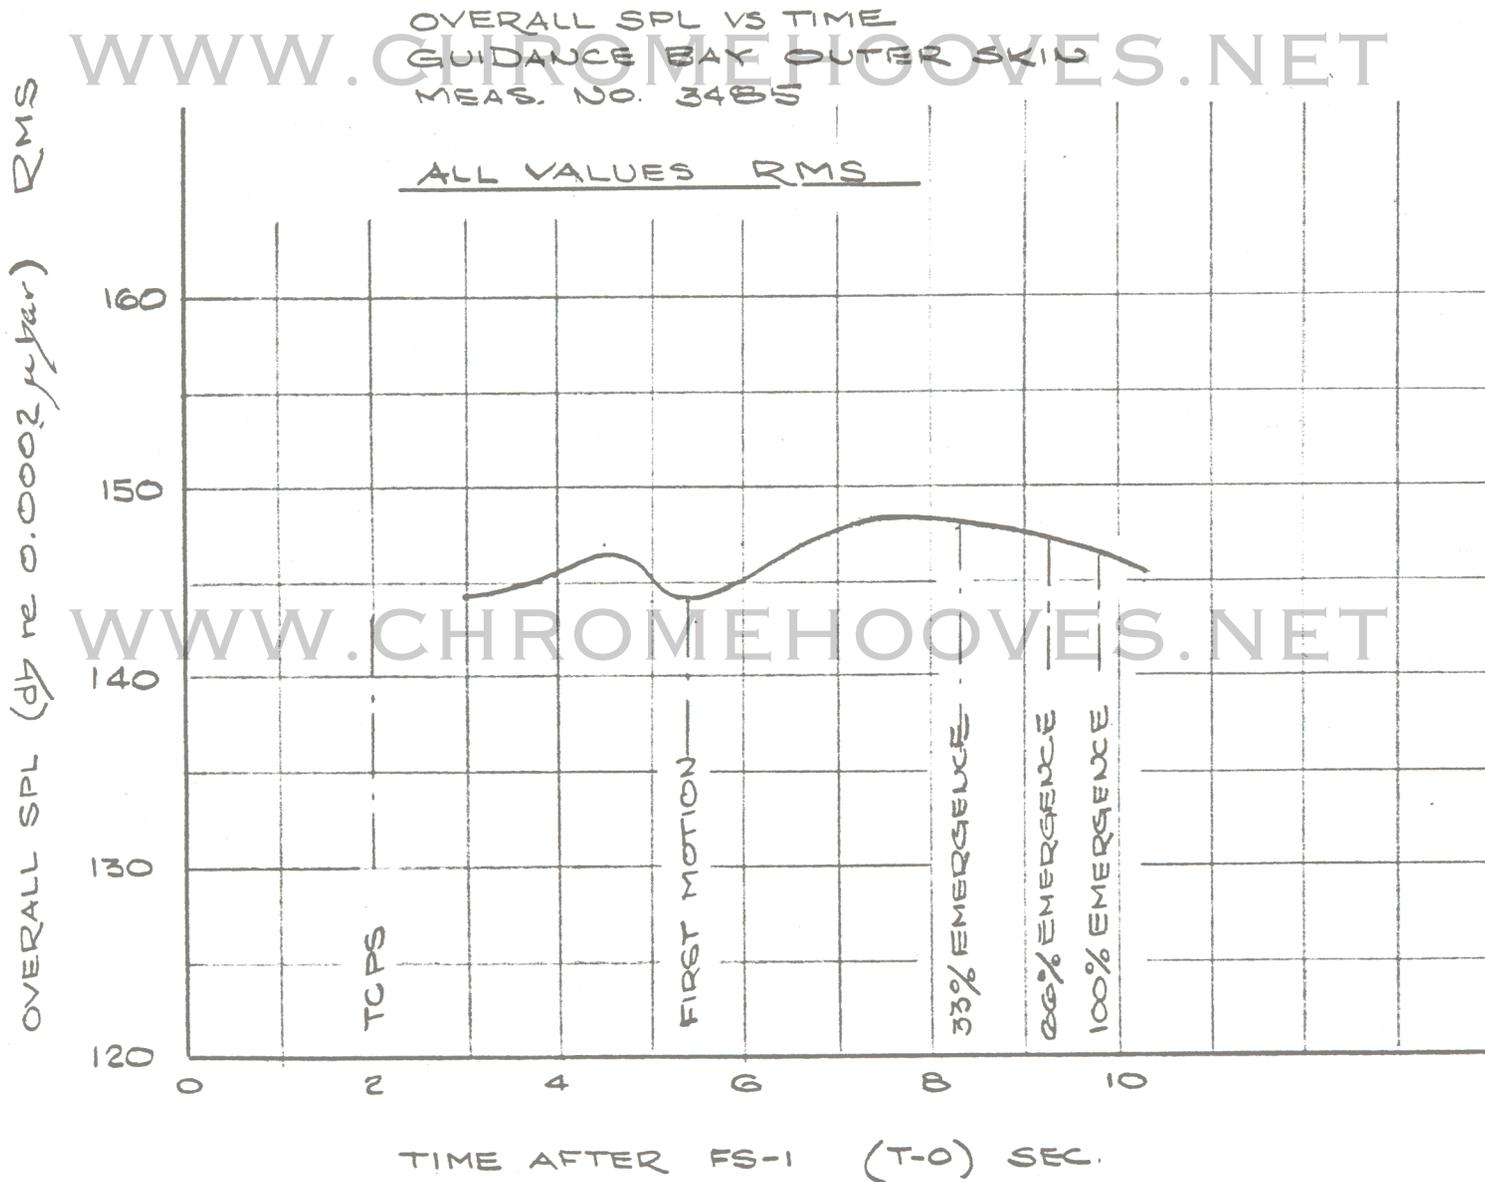
FIG 9-3

There is presently no positive explanation for the loss of these measurement channels. However, there is no indication that they malfunctioned because of inadequate installation, calibration, or checkout operations. Representative overall sound pressure levels as a function of time after FS-1 are plotted on Figures 9-3, 9-4, and 9-5.

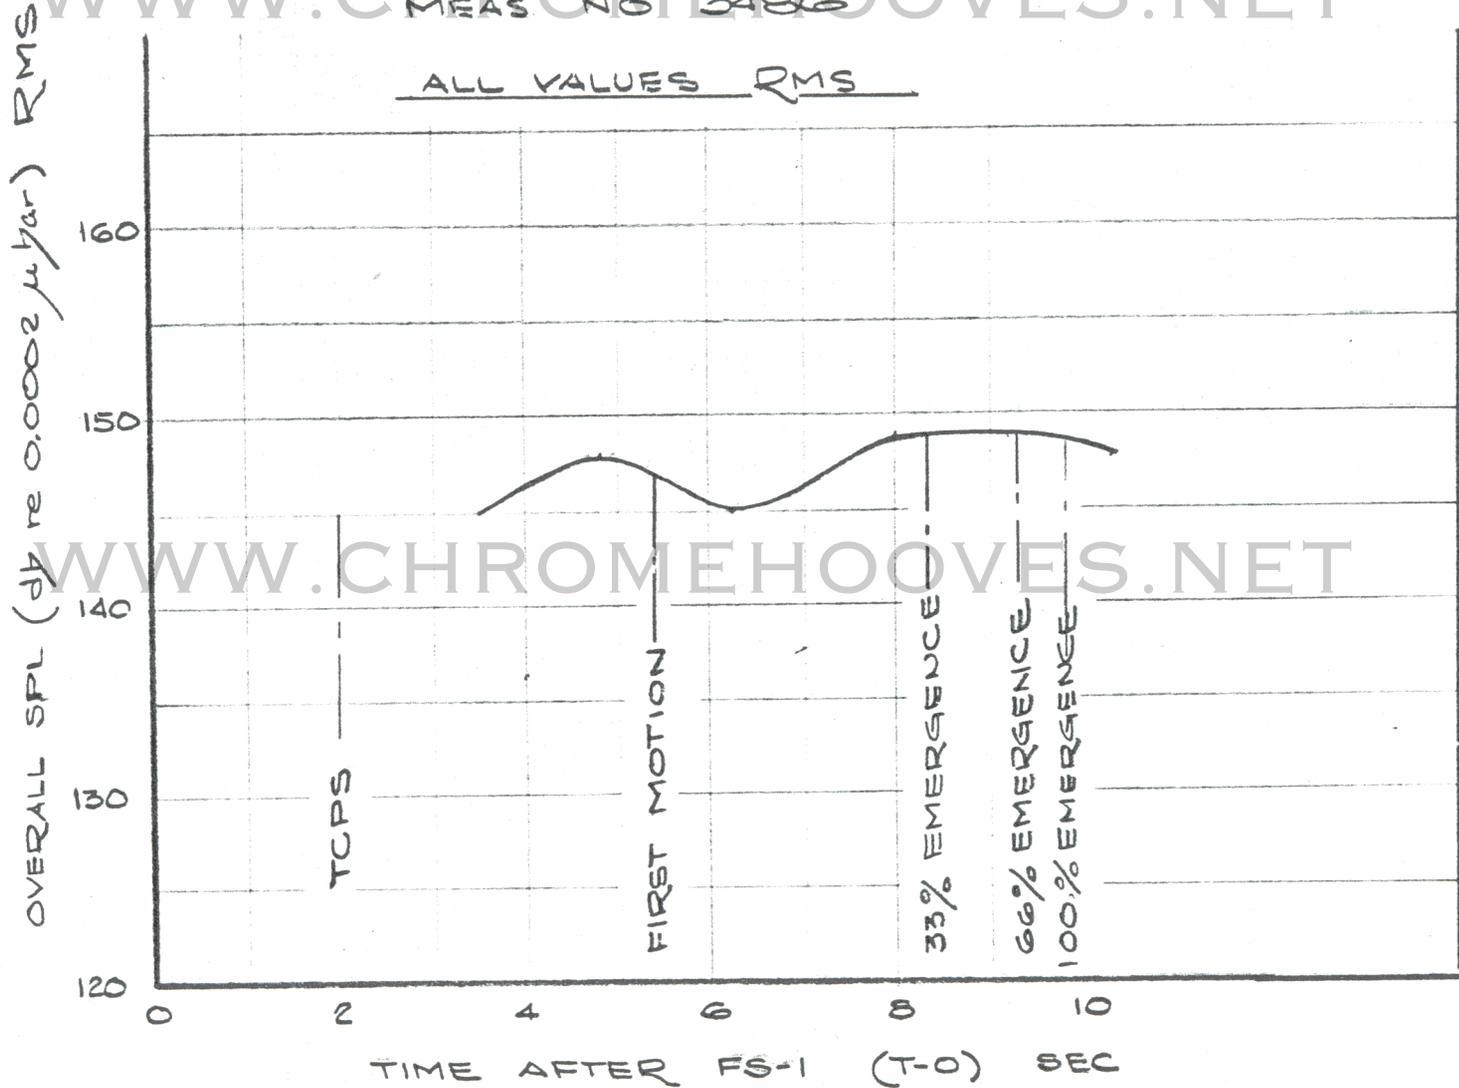
FIG. 9-4

OVERALL SPL VS TIME  
INTERSTAGE OUTER SKIN  
MEAS NO 3486
