Antenna Silos Open Cut Excavation,
Shoring of Slope, Site 1A

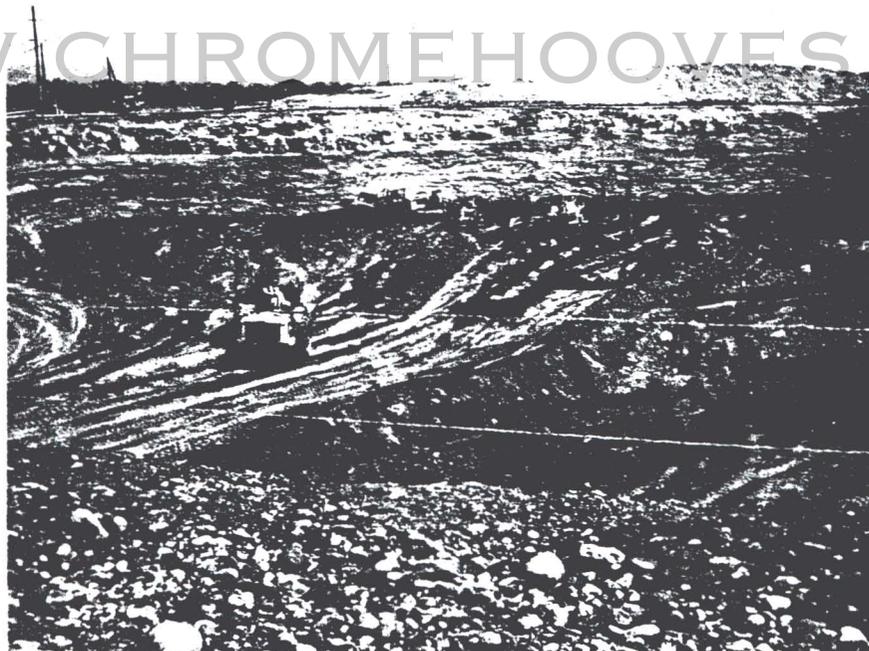
Fig. 19

Open Cut Excavation of Powerhouse,
Control Center Showing Lava Cap, Site 1C

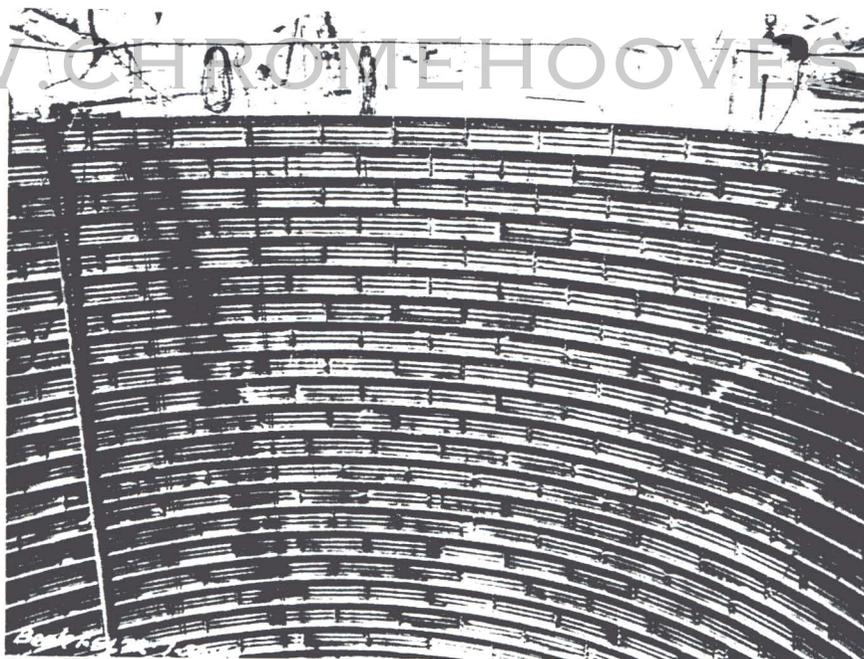
Fig. 23
Liner Plate, Missile Silo #2, Site 1A

At Site 1A the hardened granite appeared at start of shafting operations. Sequence of operations was drilling, loading and blasting, mucking, and setting of steel ring beams. At Site 1A ring beams used with wood lagging, wire mesh and gunite were part of the contractor's method of shoring. (See Figure 20) At Sites 1B and 1C, steel ring beams on 5'2" centers with wire mesh and gunite were used in accordance with a design prepared by the contractor and made a part of the contract by change order. At Site 1A the contractor proposed the use of a sectional liner plate which was used by modification to contract (See Figure 23) in lieu of the smooth plate. The sectional liner plate joints required sealing with Products Research Company's 250 rubber calk or equal. The smooth liner plate required welding at the seams.

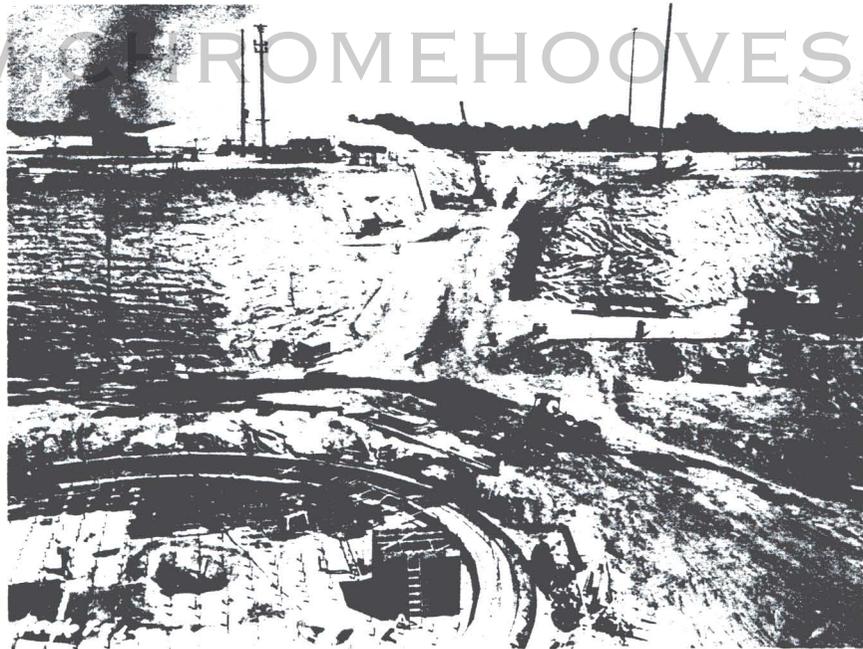
Fig. 25

adequate anchoring of the rock bolts. At Site 1A rock bolts were required to anchor the foundation slabs of all other structures in order to compensate for hydrostatic pressure. (See Figures 24 and 25 and 26) In the Missile Silo, one hundred rock bolts were required. These were 2 3/4" round bolts, 28 feet 6 inches long, 27 feet of which were grouted into the hole with non-shrink grout. The end embedded into the concrete had upset end to 3" diameter. Rock bolts for other structures were 2" round bolt, with lengths of 22', 23' 6" or 28' 6". (See Figure 27) All rock bolts were threaded at each end. The bottom nut was tack welded and at top end washers were used with the nut.

Rock Bolts, Control Center, Site 1A

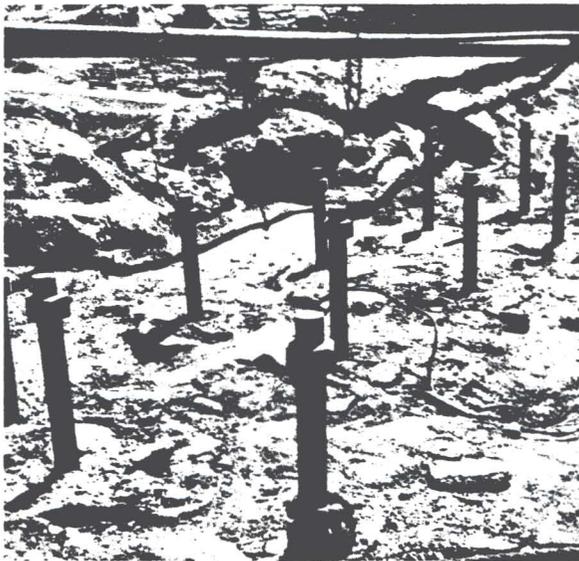
Fig. 27

Rock Bolts, Site 1A

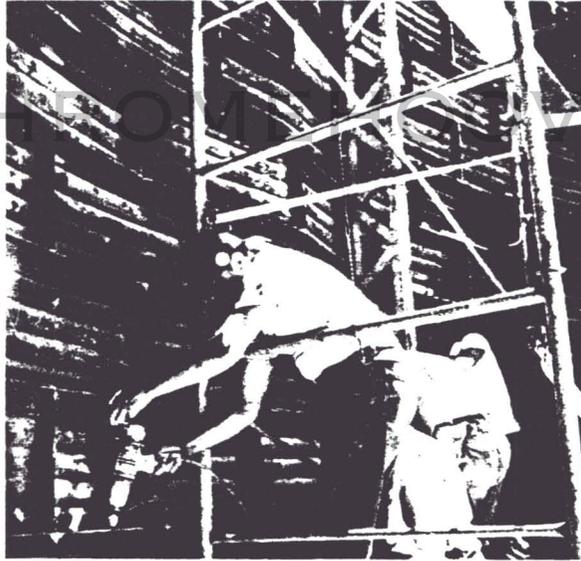
During installation of the liner plate at Site 1A, buckling of the plate caused some delay. (See Figure 28) The buckling apparently was caused by grout shrinkage which allowed water to enter behind liner plate, thus creating hydrostatic pressure of sufficient force to buckle the plates.

Buckled Liner Plate, Site 1A, Missile Silo Fig. 28

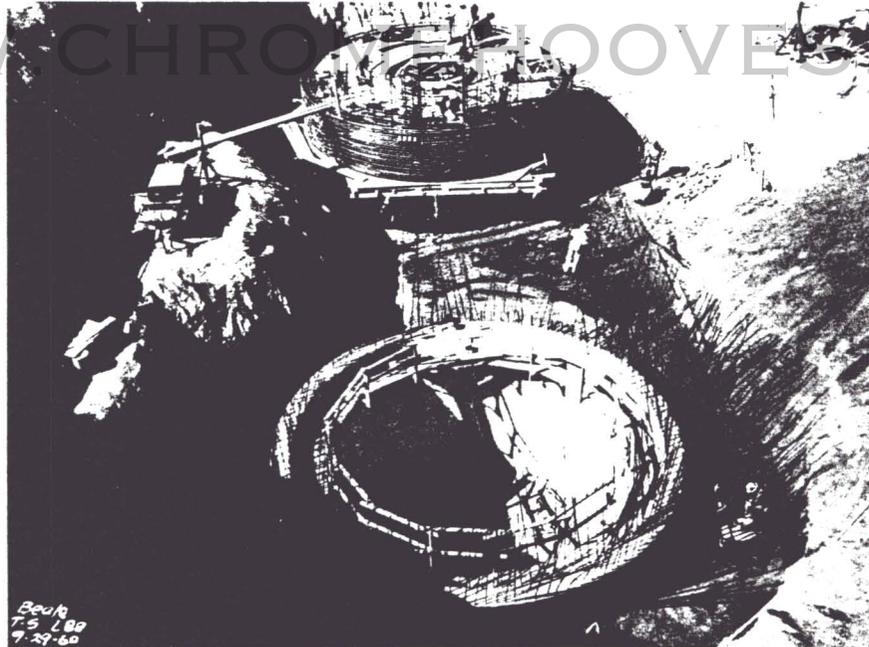
The backfilling was accomplished by the Prime Contractor. Operations began in September 1960 at Sites 1A and 1B and in October 1960 at Site 1C. At all sites the stockpile materials from the open cut excavation furnished sufficient backfill material. DW 21's and D8 Dozer with Sheepsfoot Roller were heavy equipment used. Around the structures gasoline motor powered vibratory compactors were used. (See Figure 29)

Compacting Backfill Antenna Silos, Site 1A Fig. 29

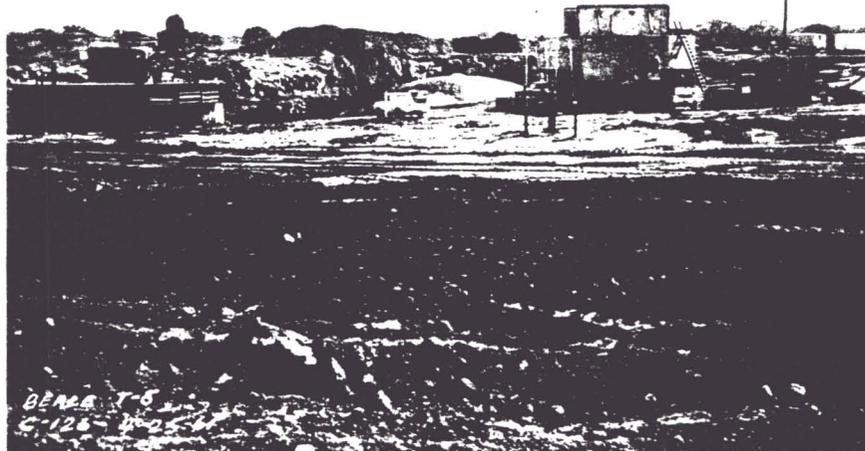
Fig. 30

Backfill Showing Rock, Site 1C

One specification requirement was changed, in that rock up to 20 inches was allowed in the fill material with the exception that within 4 feet of structures, material had to meet original specification requirements. (See Figure 30) The specifications required that rock be reduced to a maximum size of $\frac{2}{3}$ the thickness

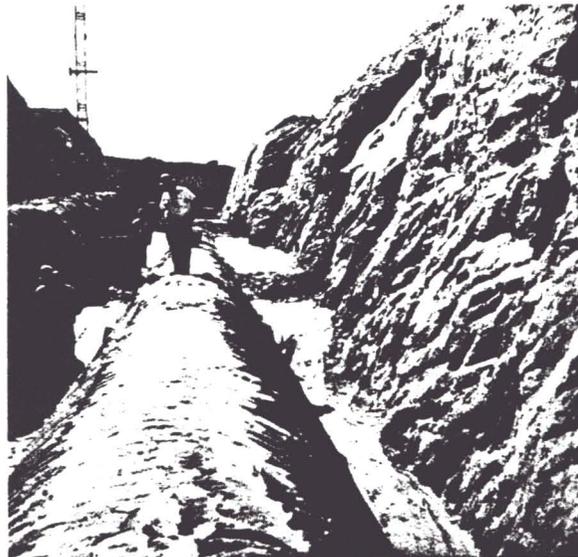
Fig. 31

Tunnel Backfill, Site 1A,
Between Tunnel Junction #10 and Antenna Terminal

The specification requirements for tunnel backfill were waived at Sites 1A and 1B, in that at Site 1A (See Figures 31 and 32) sand backfill was used underneath and up to spring line and at Site 1B, because of the suitability of the granular material, sand was not used. Specifications required that sand be backfilled beneath, above and on each side of structures.

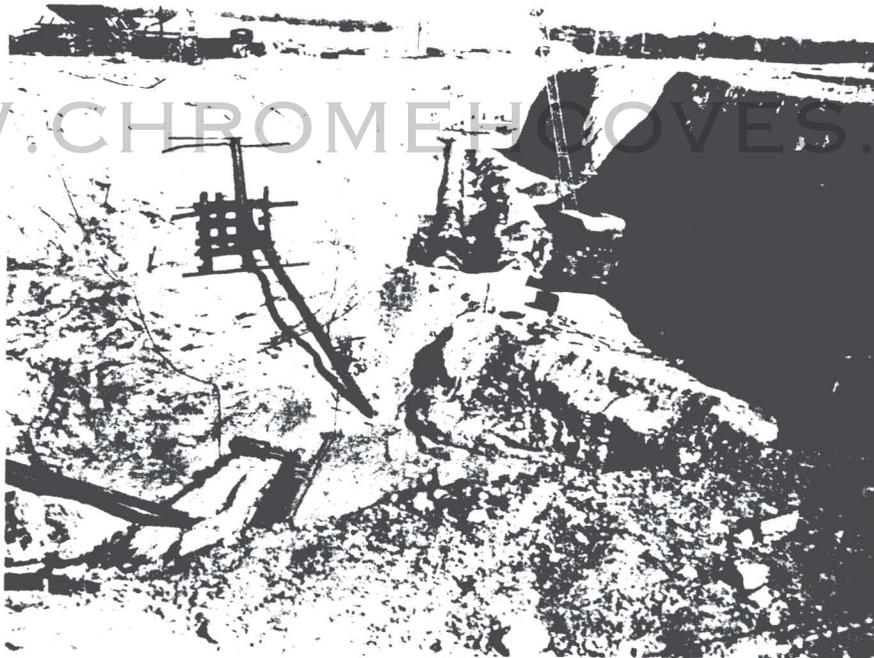
Fig. 32

Tunnel Backfill, Site 1A

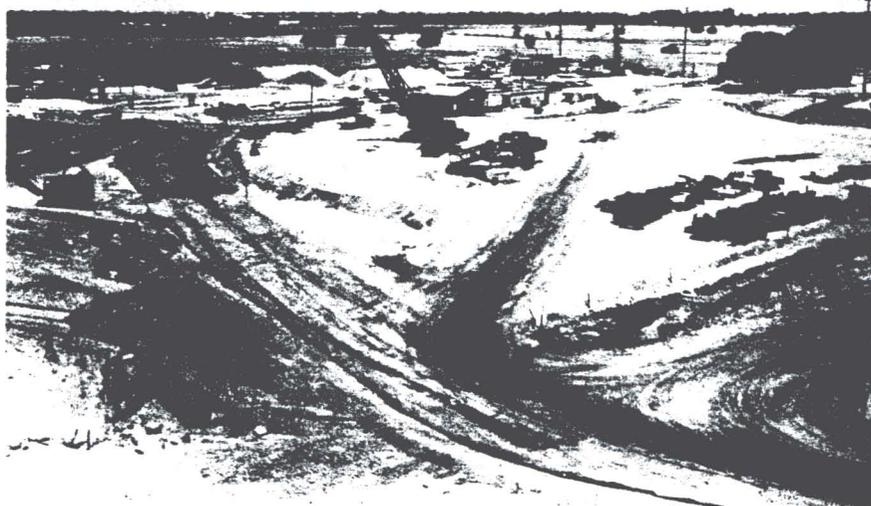
Fig. 33

Concrete Batch Plant, Site 1A

At each site a portable, automatic-controlled Noble Batch Plant with an 850 barrel storage cement silo was set up. (See Figure 33) The capacity of the plant was 80 cubic yards per hour. The sand and aggregate were dumped into the weighing batch hopper by means of conveyor belt. From the weighing hoppers, the sand, gravel and cement were dumped onto a conveyor belt and conveyed to the loading hopper. Water was metered by volume from scale room and piped to loading hopper. The air entraining agent was measured into a cylinder and by air, released into the loading hopper.

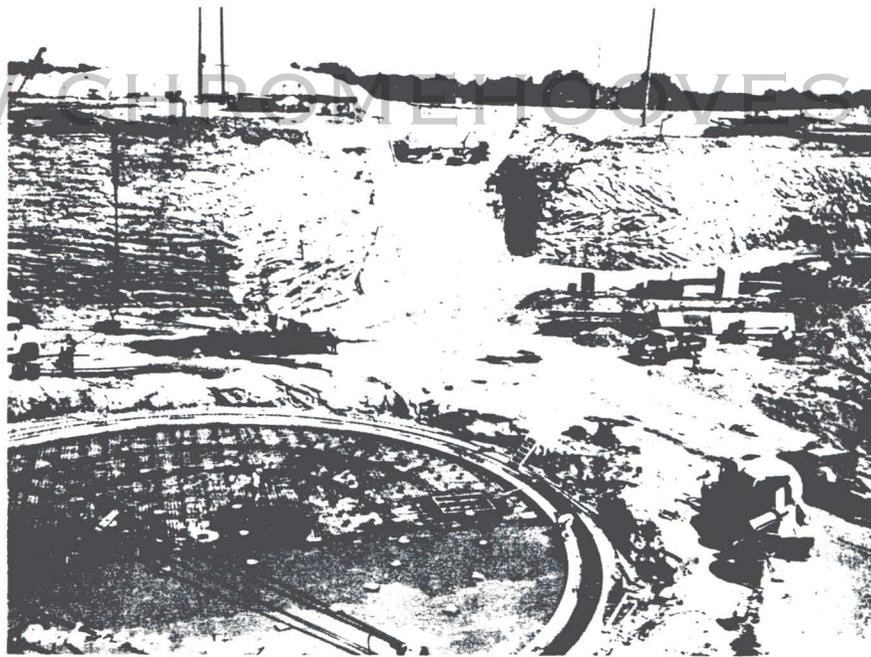
Fig. 34

Cranes using concrete buckets were utilized in placing concrete. (See Figures 34 and 35)

Concrete Placement, Control Center, Site 1A

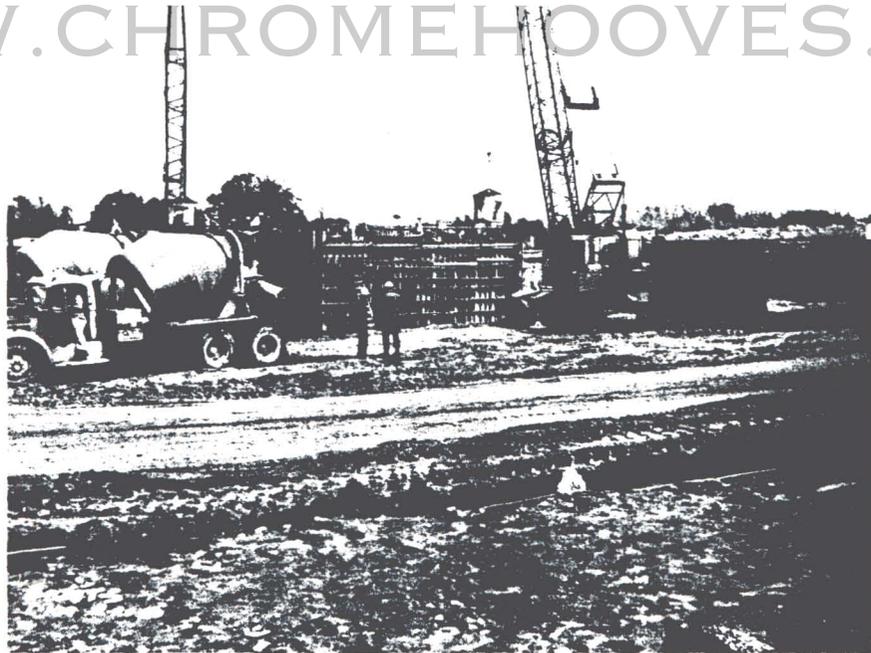
Fig. 35

Concrete Placement, Missile Silo #2, Site 1A

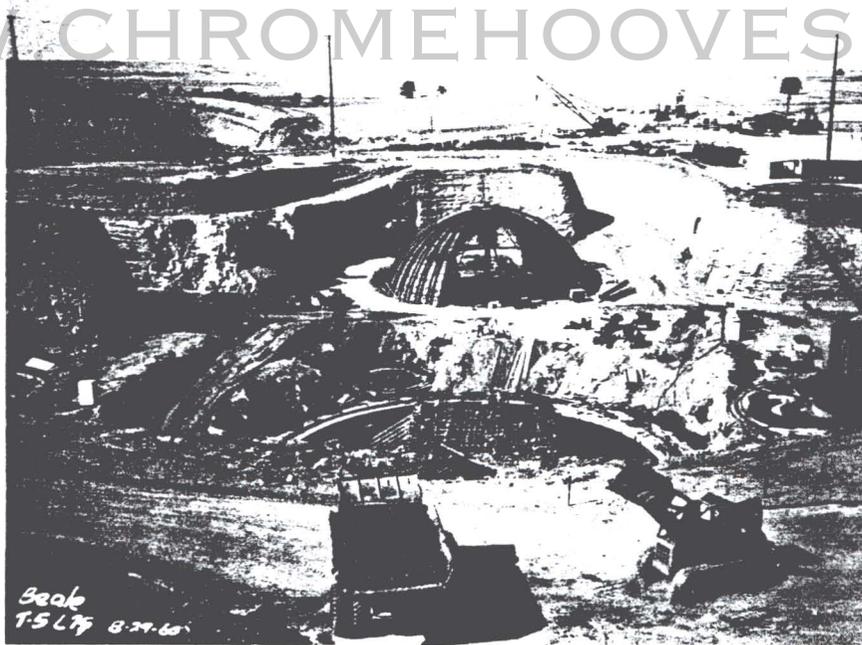
Fig. 41

The forms for the Control Center and the Power House domes were movable steel forms. (See Figures 41, 42 and 43)

Movable Steel Forms, Control Center, Site 1A

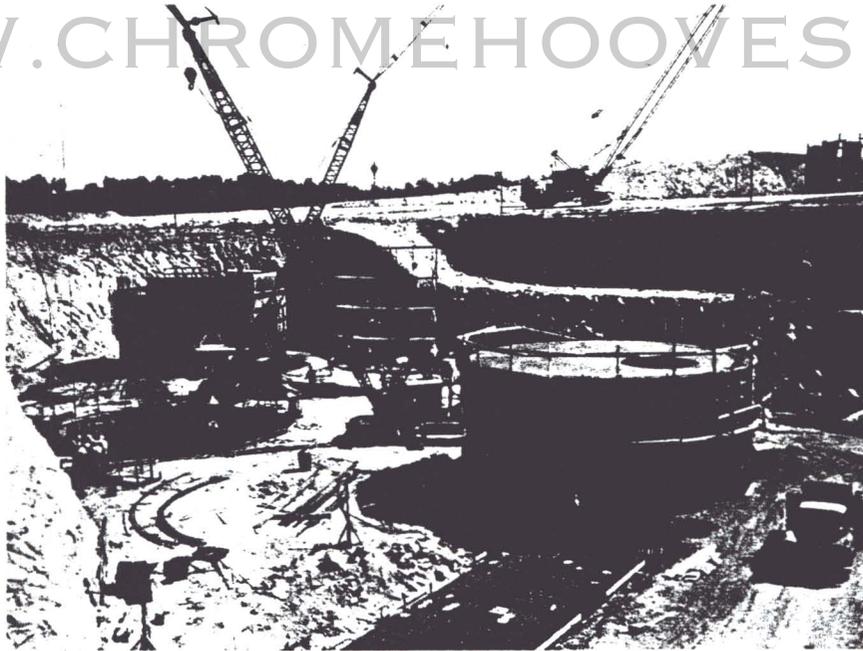
Fig. 55

Four Deck Scaffold, Steelworkers,
Missile Silo #2, Site 1A

Resteel was placed in accordance with normal construction practices. (See Figures 50, 51, 52, 53 and 54) For the placing of the wall resteel in Missile Silos, swinging platforms, one a single deck and the other with four decks, (See Figure 55) were used. These platforms were raised and lowered by crane.

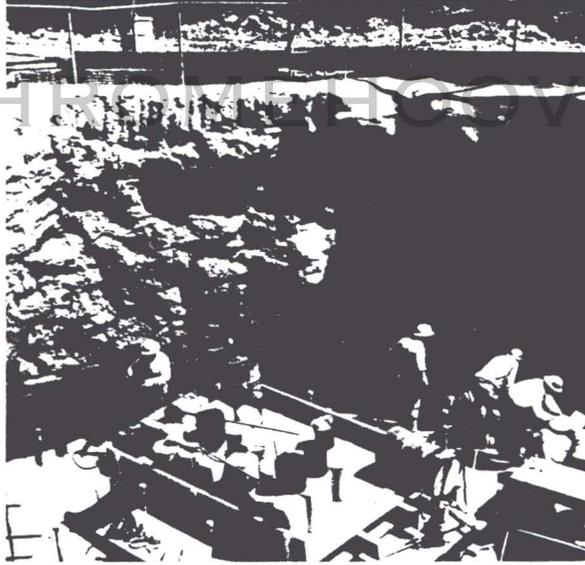
Because of the seepage water conditions at Site 1A, all concrete structures were waterproofed. (See Figure 61) At Sites 1B and 1C the structures were dampproofed. The waterproofing and dampproofing operations proceeded exceptionally well and only minor problems were encountered. An asphalt primer was applied for both the dampproofing and the waterproofing. Two coats of hot asphalt were applied for the dampproofing. (See Figure 62) For waterproofing, five ply of thermoplastic bitumen treated fibrous glass membrane was applied with hot asphalt and protected on outside surfaces by fiber board. Inside foundation surfaces were protected by grout. Rock bolts were waterproofed with sealant.(See Figure 63)

Waterproofing, Site 1A, Propellant Terminal Footing Fig. 61

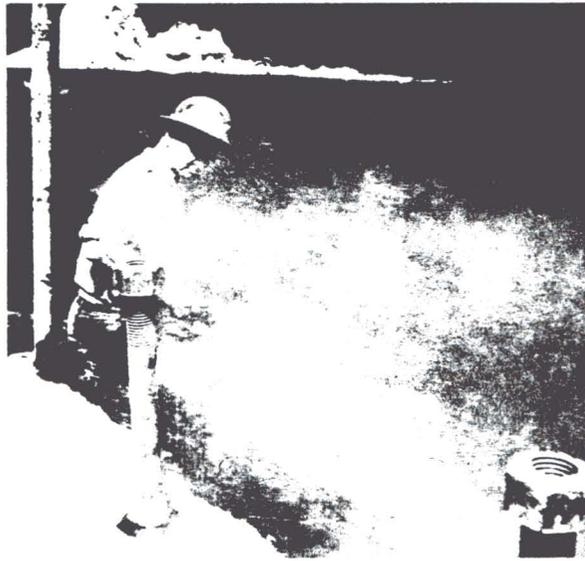
Fig. 62

Waterproofing, Site 1A

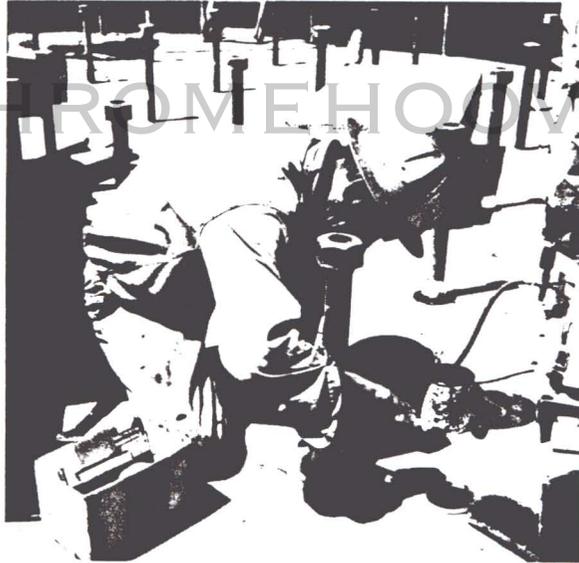
Fig. 63

Waterproofing, Rock Bolts, Site 1A

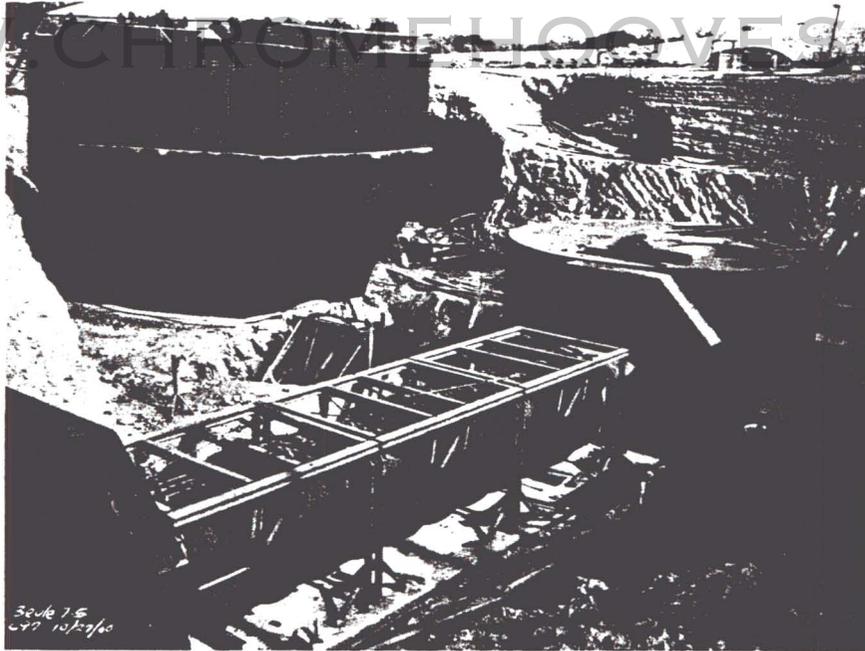
Fig. 64

Structural Frame, Liquid Oxygen Tank, Launcher #2,
Site 1A

At each site three Liquid Oxygen Storage tanks were installed. These tanks were 56'6" in overall outer shell length, 11'6" in outside diameter and weighed 125,000 pounds empty. Each tank, for shock mounting, was suspended by hangers from a structural frame. This structural frame was supported from the foundation slab by steel columns. (See Figure 64) The tanks were protected by a rolled steel channel shell. (See Figure 65) Two 30 ton cranes were used in setting tanks. (See Figure 66) The tanks were shipped by railroad to nearest siding and then transported by truck to the sites. (See Figure 67) Tunnel excavation and installation were underway during this period which limited space available for truck and cranes.

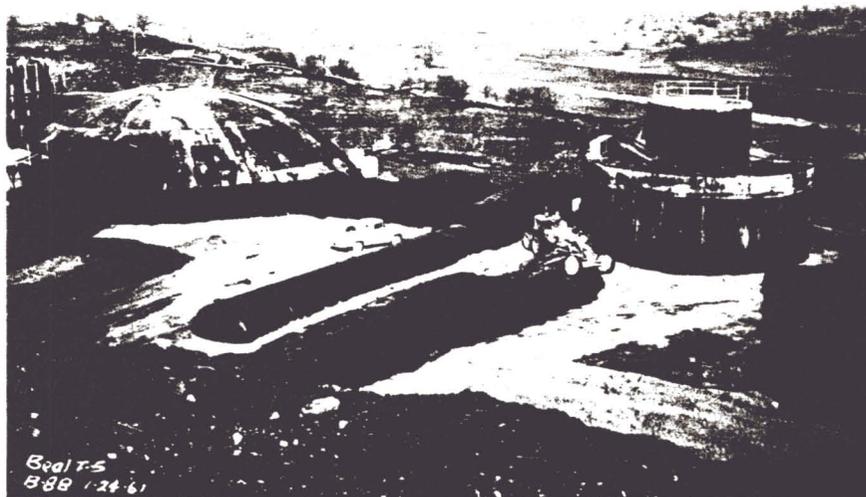
Diesel Fuel Storage Tanks, Site 1B Fig. 68

Three diesel fuel storage tanks were installed at each site. (See Figure 68) Two of the tanks were 80' 0" in overall length and 12' 0" in outside diameter. The third tank was 24' 0" in overall length and 6' 0" in outside diameter. No unusual problems were encountered during installation.

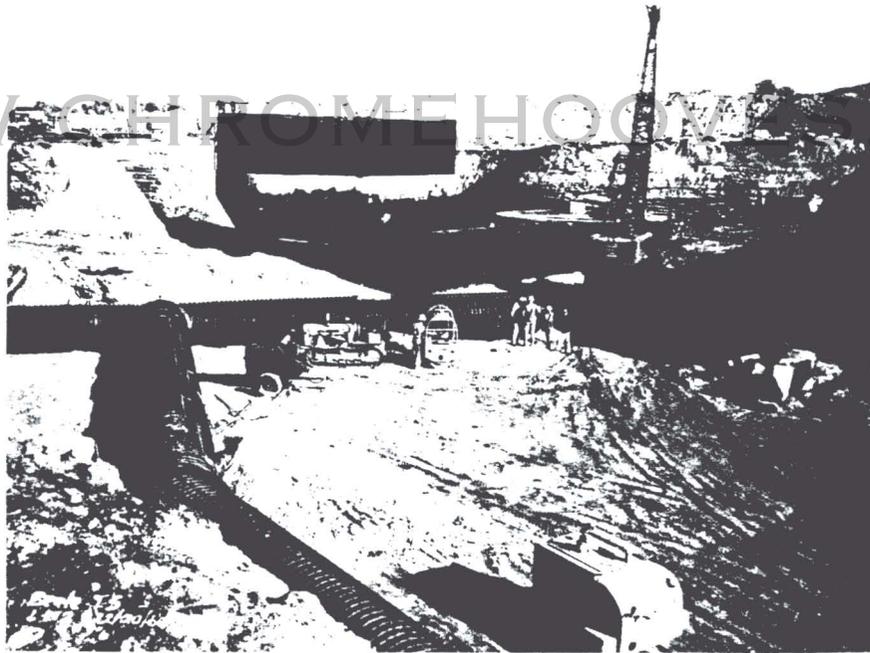
Fig. 70

Ventilation Tunnel, Site 1A

The Armco Drainage and Metal Products Company installed the steel tunnels and tunnel junctions. The tunnel system consisted of personnel tunnels (See Figure 69), utility tunnels, PLS interconnecting tunnels, ventilation tunnels (See Figure 70), tunnel junctions (See Figure 71) and Antenna Terminal. Two reinforced concrete blast locks, not part of Armco's work, provided blast protection from each launcher. (See Figure 72) In the ventilating tunnel system an air filtration structure provided for the air supply. (See Figure 73)

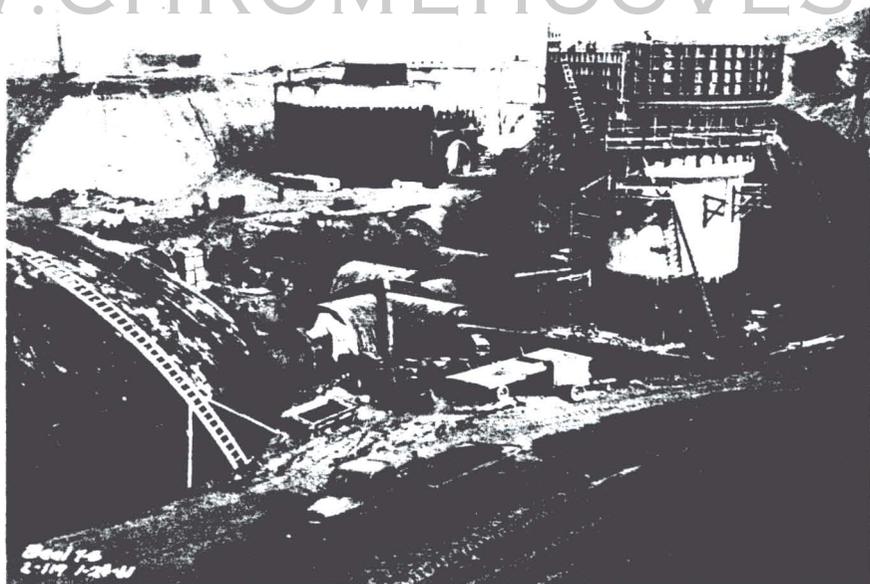
Fig. 71

Tunnel Junction #10, Site 1A

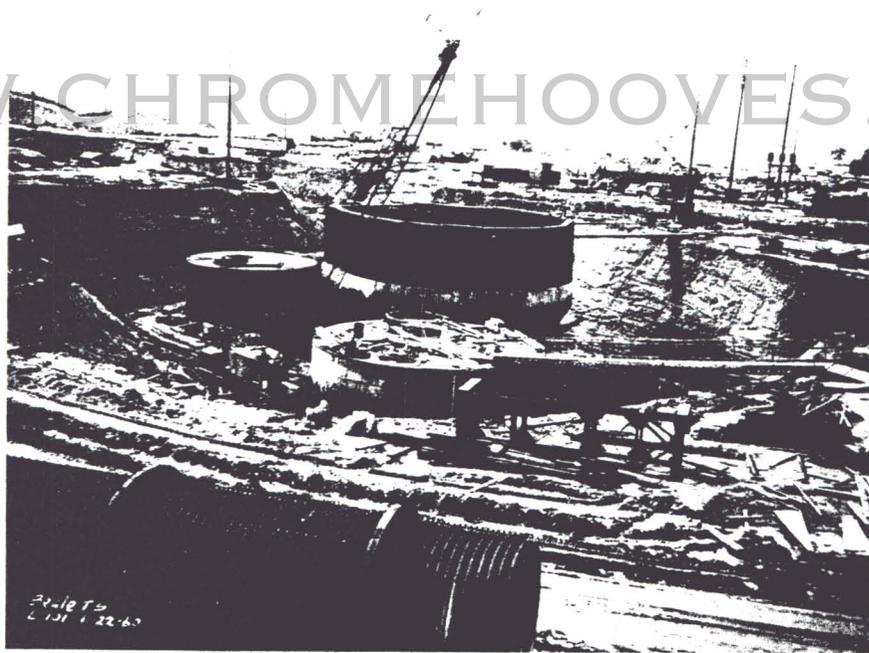
Steel Tunnel Section Showing Ring Beams, Site 1A Fig. 74

The tunnel sections installed for the tunnel between Tunnel Junction 10 (Power House - Control Center) and the Antenna Terminal were preformed in the shop to a 3 percent larger vertical diameter. The tunnel section for remaining tunnels, with exception of the ventilating tunnel, were fabricated with ring beams, spaced 14 feet. (See Figures 74 and 75)

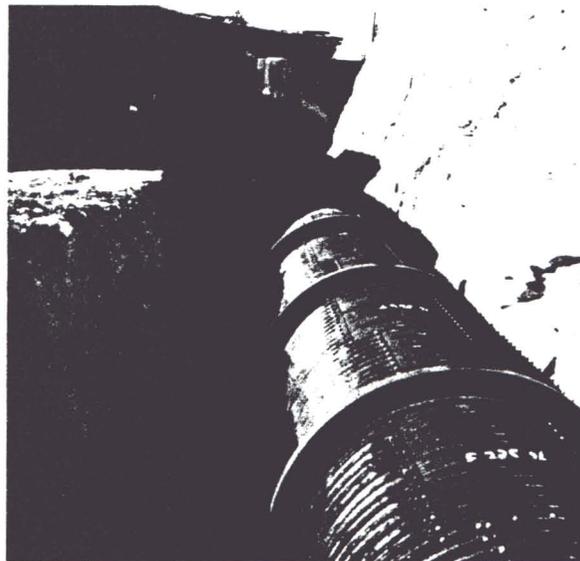
Fig. 75

Steel Tunnels Showing Rings, Site 1A
Blast Lock #2 to Tunnel Junction #2

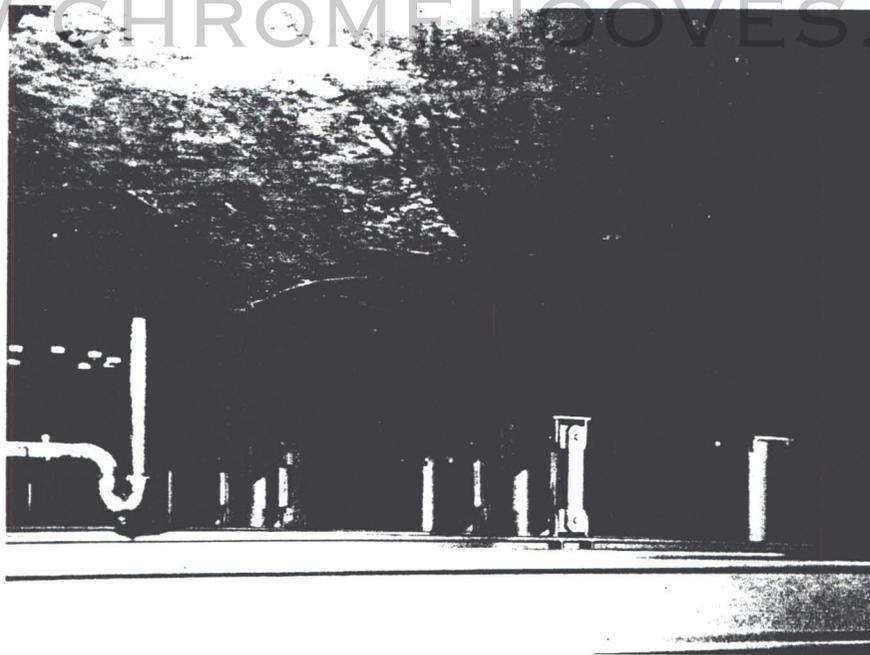
Fig. 79

The reinforced concrete floor of the first level of the Control Center was supported from the foundation slab by structural shock beams. (See Figure 79) The upper level floor was supported by wide flanged steel beams which were supported from the main floor by 10" I.D. pipe columns, extra strong. The outer portion of the upper floor was cantilevered. The Austin Western Hydraulic crane was used from the lower floor in erecting the structural steel.

Spring Beams, Control Center, Site 1C
