PROBLEM AREAS

Modification No. 1 to Contract No. DA-25-066-eng-5558 was issued within 60 days after award of the contract, revised some 409 drawings, issued 39 new drawings, deleted 15 drawings, and issued 562 pages of specifications. This modification delayed normal contract administration activities until the modification was settled at a cost of \$4,937,373 on 27 August 1960 over 16 months after award of the contract. Most of the Area Office's estimating and negotiating talent was devoted to this modification until settled.

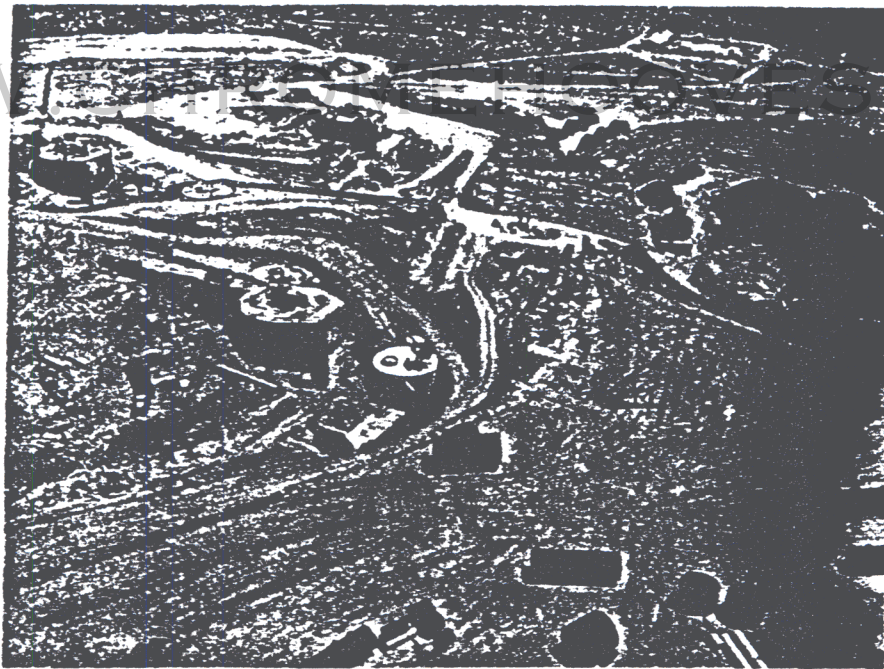
Typical aerial view showing progress to August 1960 showing much of tunnel in place and backfilled. Remaining prefab tunnel sections and junctions in foreground are awaiting placement.

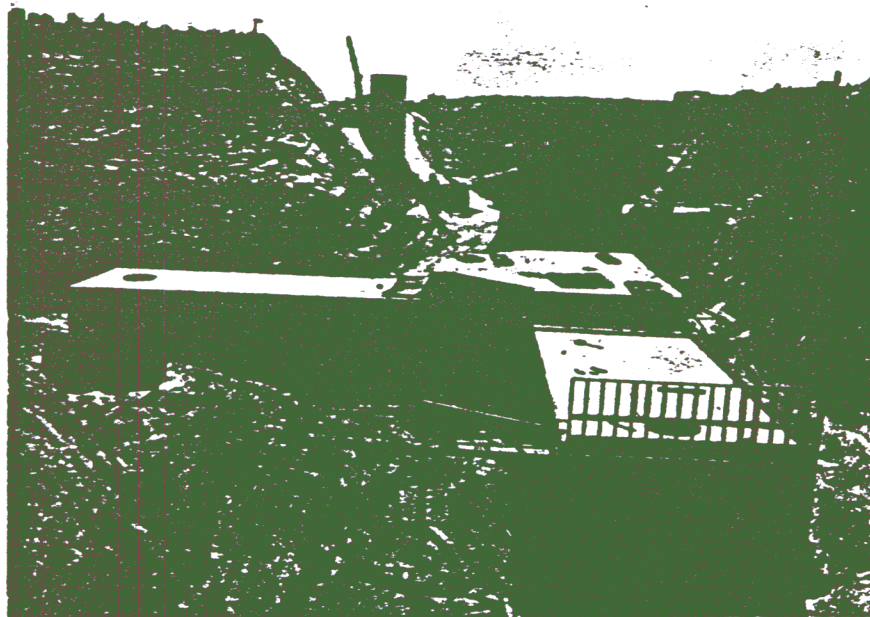
Blast Lock No. 1 placed. Note forming for Blast Lock No. 2 in background.

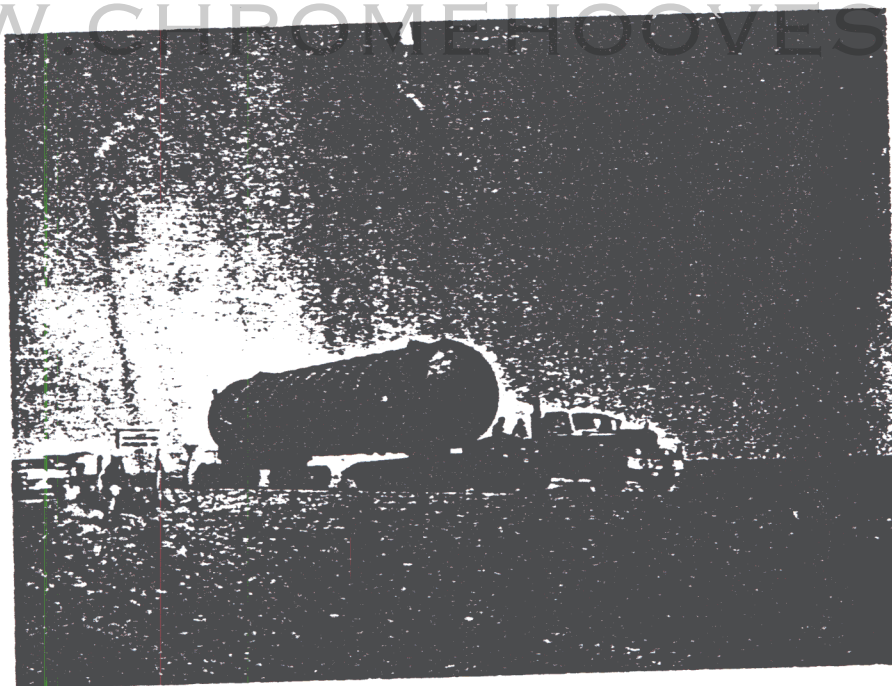
View of T-201 LOX tank being transported from Buckley Field to a launching site.

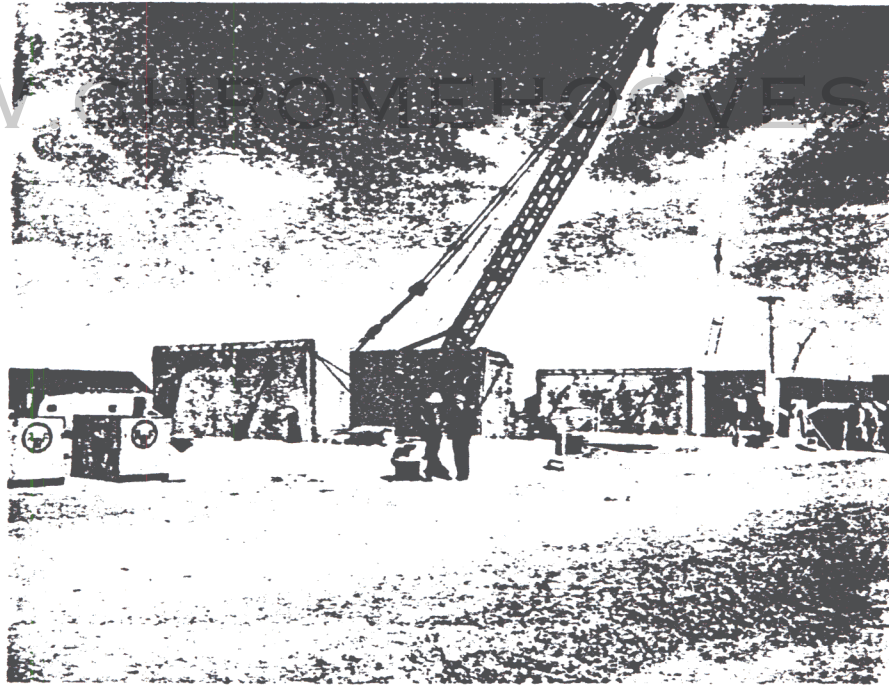
TYPICAL VIEW OF ANTENNA SILO AREA WITH SILO DOORS OPEN
